# Topographic and Geological Features Involved in Water Leakage at Levee Foundations and in Levee Body Deformation by Piping on the Kakehashi River

Yutaka SATO, Shoji FUKUOKA (Research and Development Initiative, Chuo University, Tokyo, Japan)

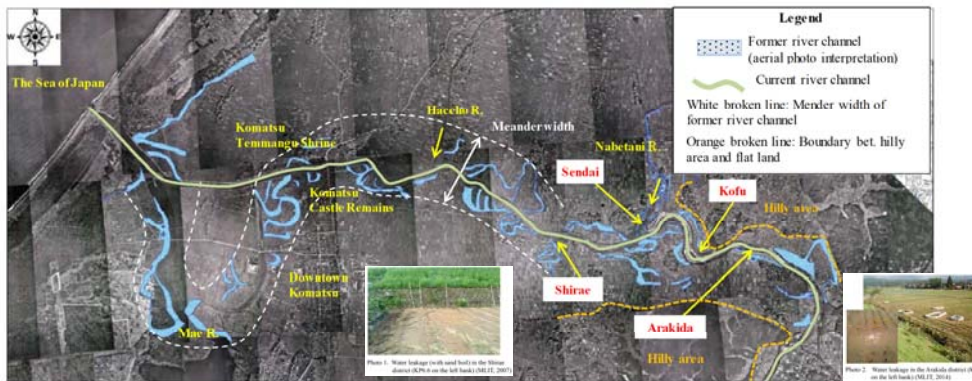
Water leakage took place on the river section upstream of the Haccho River. On that section, a bed of highly permeable gravel is distributed in the foundation layer (Figure 1,2.)

Figure 1. The former river channels of the Kakehashi River identified in U.S. military aerial photos, and places of water leakage (MLIT, 2008)

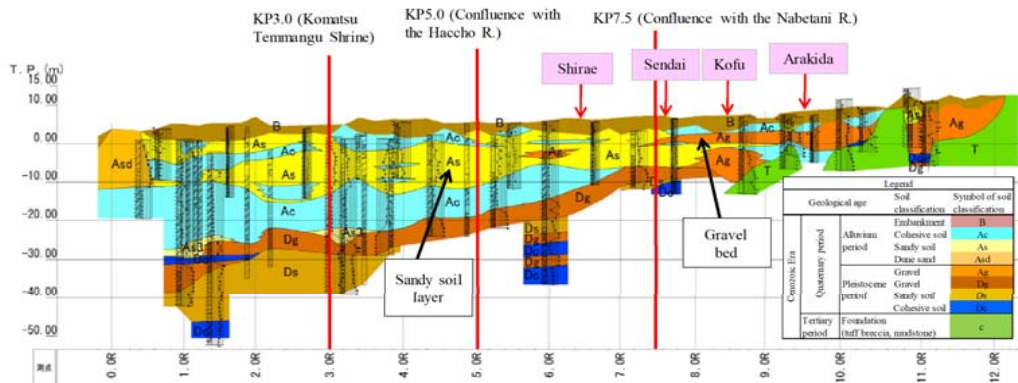
Figure 2. Longitudinal geological profile along the levee on the right bank of the Kakehashi River (MLIT, 2014)

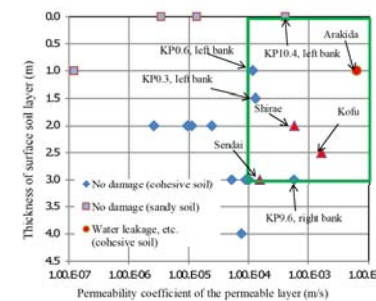
Water leakage occurred at places where cohesive soil is distributed near the ground surface, the surface layer is 1~3m thick, and the k of the permeable layer is at least 10-4m/s (Figure 5.)

Figure 5. Relationship between the permeability coefficient of the permeable layer and the thickness of the surface layer

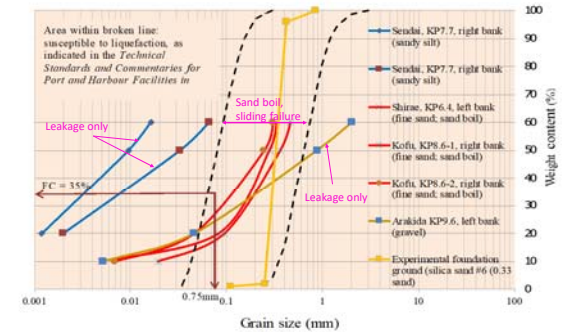
Figure 11. Grading curves for the soil of sand boil sites

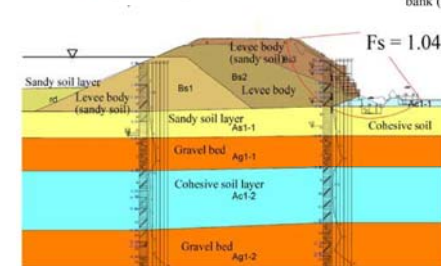
At KP8.4 on the right bank, the minimum safety factor is 1.046, which is higher than 1; thus, sliding failure did not occur (Figure 8.) A portable cone penetration test conducted after the levee failure, indicates that part of the sand layer in the foundation ground is relatively weak. Because the location, shape and the dimensions of the weak part are consistent with those of the calculated circular sliding surface, it is possible that the sliding failure was due to a decrease in the effective stress caused by an increase in hydrostatic pressure (Figure 9.)

Figure 8. Geological profile at KP8.4 on the right bank (MLIT, 2014)

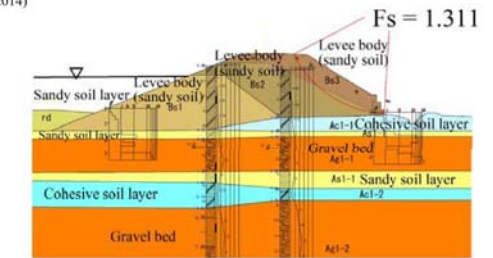
At KP8.6 on the right bank, even when the strength of the sand layer decreases because of failure due to piping (on the assumption that the angle of shear resistance  $\phi=0$ ), the safety factor is 1.149. A safety factor higher than 1 means that sliding failure does not occur (Figure 10.)

Figure 10. Geological profile at KP8.6 on the right bank (MLIT, 2014)
