A SUITABLE RISK INDEX FOR EVALUATING BRIDGE DAMAGE IN THE MISASA RIVER CAUSED BY THE 2018 WESTERN JAPAN FLOODS

The 2018 Western Heavy Rainfall caused huge floods across a wide area of western Japan on July 5–8, 2018, followed by significant damage to people and their homes. In the Misasa River, which is a branch of the Oota River, Hiroshima prefecture, Japan, 22 out of 94 bridges were damaged by the flooding. The purpose of this study is to examine the characteristics of the bridge failures in the Misasa River. We also propose an index suitable for bridge damage assessment under heavy rainfall based on the longitudinal distribution of bridge damage in the Misasa River. From the results, it is statistically clear that the characteristics of the bridge damage can be related to the non-dimensional cross-sectional area (= cross-sectional area / upstream catchment area) and girder thickness / hydraulic radius. An evaluation procedure for bridge damage risk using these indicators is also examined on a trial basis.

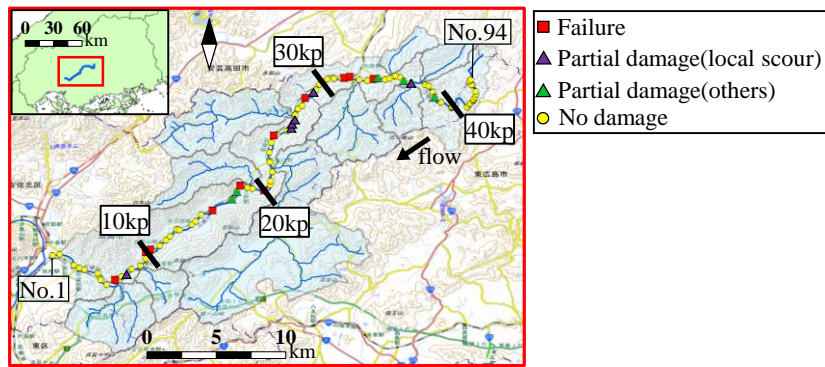
Figure 1. Study site and map of bridge damage caused the 2018 Western Heavy Rain.

Before comparing various risk indices for bridge damage, we examined the longitudinal distribution of the bridge damage, inundation area, and dike height along the whole Misasa River. The inundation area was concentrated in the middle reach of the Misasa River, and there was almost no flooding in the upstream area. Bridge damage was also concentrated in the middle reach, especially from 15 to 35 km from the conjunction of the Oota River. The failure of the bridges occurred in the inundation area.

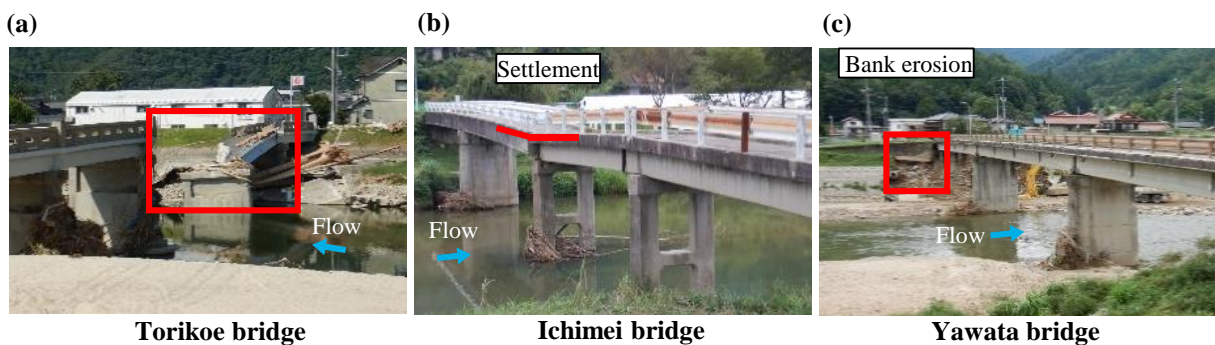
To assess bridge damage in the Misasa River, we conducted four field surveys on all 94 bridges on the river from August to December 2018. The bridge numbers were determined as shown in Figure 1. The bridge damage was classified into four types: failure, partial damage (local scour), partial damage (other), and no damage. *Failure* meant a collapse of bridge girders, and *partial damage* was subdivided into damage factors: local scour of piers and other. Figure 2 shows examples of each type of bridge damage. The map created of the bridge damage is shown in Figure 1. Among the 94 bridges, we found 11 failures, 6 partial damages (local scour), and 5 partial damages (other).

Figure 2. A classification of bridge damages: (a) failure, (b) partial damage (local scour), and (c) partial damage (other).

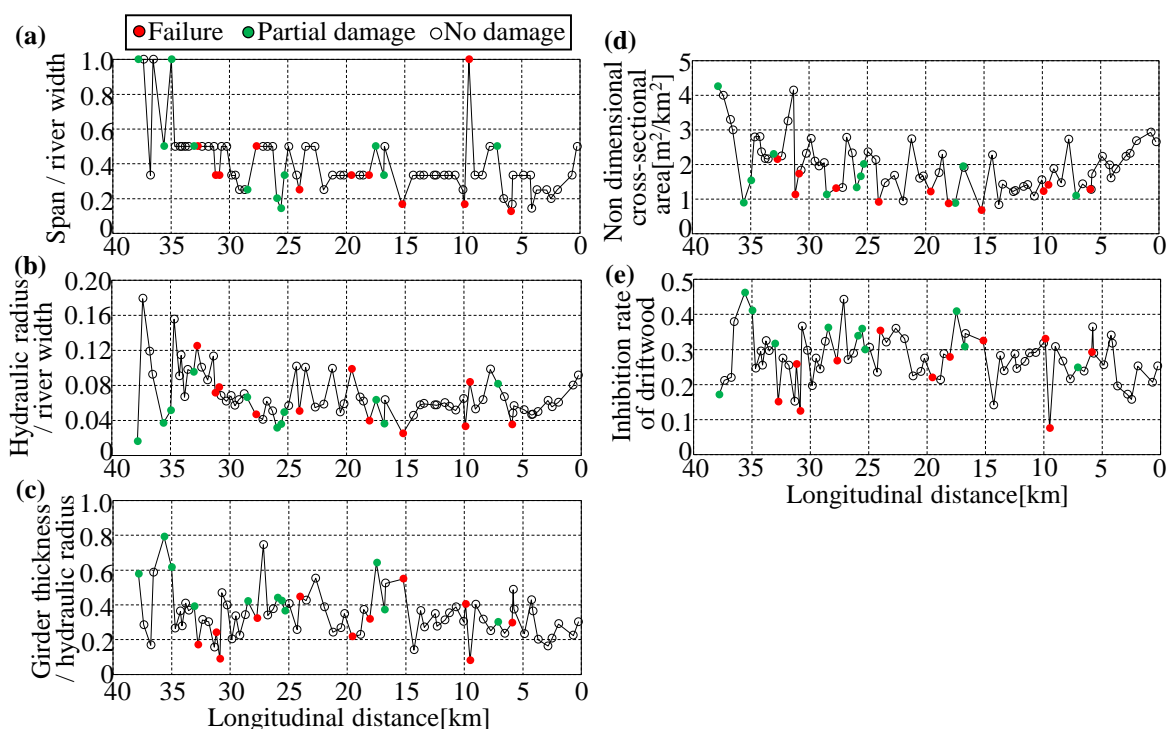
Figure 3 shows the longitudinal distributions of the non-dimensional indices of various hydraulic and bridge factors. From various non-dimensional indices, we selected span / river width, hydraulic radius / river width, girder thickness / hydraulic radius, non-dimensional cross-sectional area, and inhibition rate of driftwood. Non-dimensional cross-sectional area is defined as the cross-sectional area divided by the catchment area at a target site. Inhibition rate of driftwood is the ratio of the projection area of driftwood captured on piers to the cross-sectional area. Examination of span / river width and hydraulic radius / river width failed to find a clear correlation between bridge damage and either index, as shown in Figure 3(a) and (b). Local minimum and maximum values of girder thickness / hydraulic radius appeared at the failures and partial damages, respectively, as shown in Figure 3(c). However, differences in the girder thickness / hydraulic radius between no damage and either failure or partial damage were not clear. Local minimum values of the non-dimensional cross-sectional area almost corresponded to the failure and partial damages, showing a good correlation between non-dimensional cross-sectional area and bridge damage, as shown in Figure 3(d). The non-dimensional cross-sectional area is the ratio of the cross-sectional area to the upstream catchment area, which is closely related to river discharge. This means that the non-dimensional cross-sectional area corresponds to discharge capacity. The catchment area and cross-sectional area ranged from 14 to 267 km² and from 69 to 958 m², respectively. It means that the non-dimensional cross-sectional area ranged from 1 to 5 [m² / km²]. A smaller non-dimensional cross-sectional area indicates a smaller discharge capacity, which causes bridge damage. As shown in Figure 3(e), the variation pattern of the inhibition rate of driftwood was almost the same as that of girder thickness / hydraulic radius.

The above tendency was confirmed quantitatively by statistical analysis using a t-test. Based on the results, we selected the non-dimensional cross-sectional area and girder thickness / hydraulic radius together as the indices to evaluate bridge damage. It is noted that the non-dimensional cross-sectional area with the inhibition rate of driftwood would also be useful.

Figure 3. Longitudinal distribution of non-dimensional indices of bridge damage: (a) span / river width, (b) hydraulic radius / river width, (c) girder thickness / hydraulic radius, (d) non-dimensional cross-sectional area, and (e) inhibition rate of driftwood.
