EXTRACTION OF SLOPE FAILURE BEHIND AGRICULTURAL RESERVOIRS DUE TO HEAVY RAINFALL USING REMOTE SENSING

HAJIME SHIROZU

KOJI ASAI

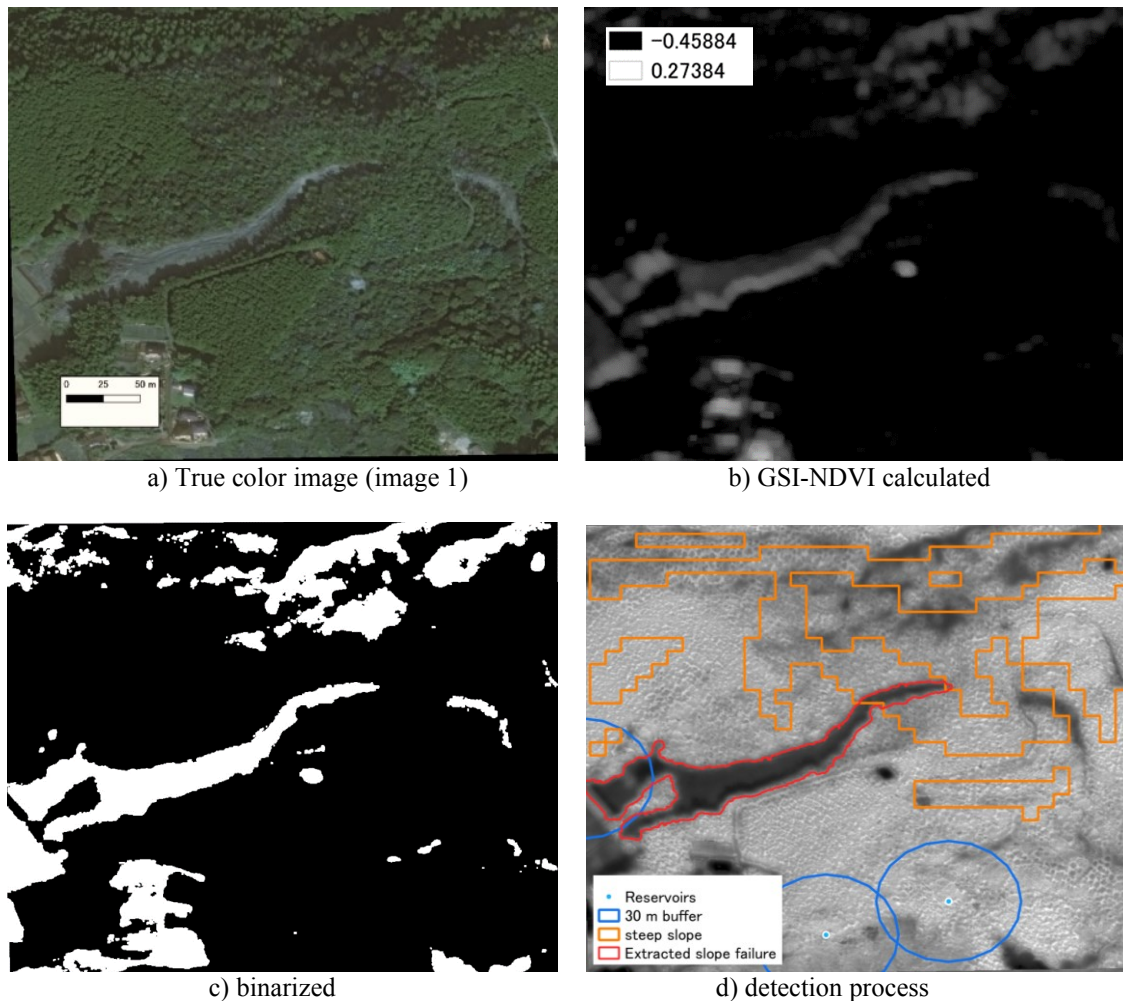
Figure 2. procedure of VNIR analysis at Morishige reservoir

Here, IR, R, G, and B indicate the values of the near-infrared, visible red, visible green, and visible blue bands of the pixels in the image respectively. NDVI and GSI are obtained from the VNIR image after the disaster. GSI / NDVI difference images were processed. As an example, Figure 2 shows a slope failure site around

Morishige Reservoir in Kuga. On the Geographic Information System, the GSI / NDVI difference value of the pixel in the image was set to 0.20 as a threshold, and pixels having the calculated value larger than the threshold were extracted as bare areas then the polygons are created. Next, only those polygons located on a slope with a slope of 25 degrees or more and within 30 m around the reservoir were extracted as collapse sites behind the reservoir. Figure 2(b) shows the results.

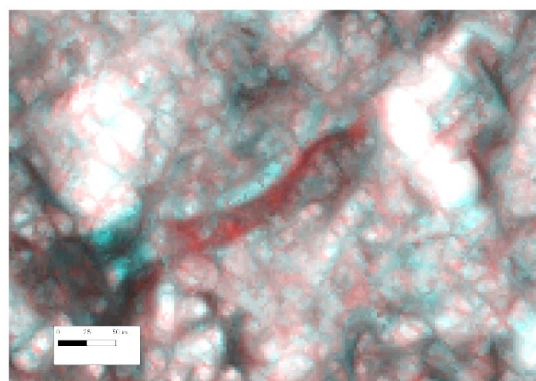
Figure 3. additive color SAR image at Morishige reservoir; image 2 (Red) and image 3 (Cyan)

SAR images were analyzed using the additive color method. In this method, the single polarization monochrome image before the disaster is assigned to the red band, and the image after the disaster is assigned to the blue and green band. As an example, Figure3 shows the processing results at the slope failure around the Morishige reservoir. The spots where the scattering intensity has increased after the disaster are seen in cyan, and the spots where the scattering intensity is weak appear in red. For example, in places where the scattering intensity is high, it is considered that the vegetation area has changed to a bare area due to slope failure. Such processing was performed in the area including Kuga and Shuto region in Iwakuni City, and the northeastern tip of Shunan City.

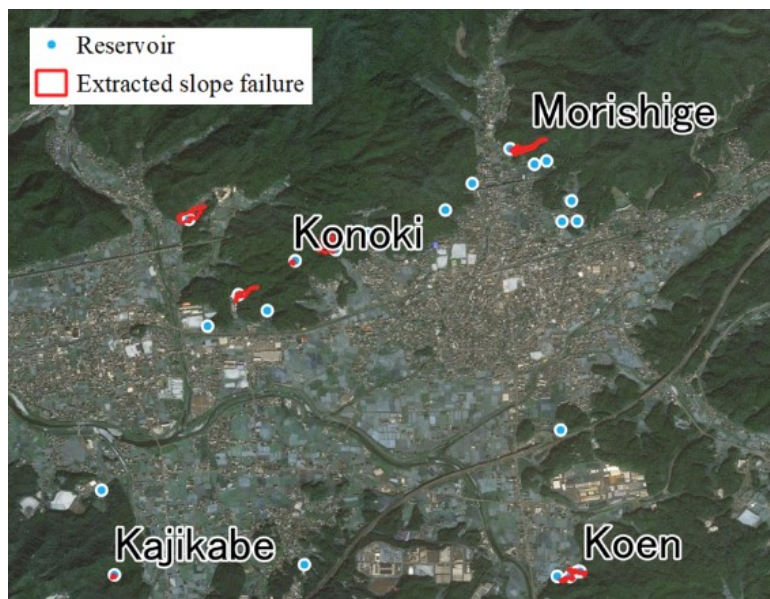
Figure 4. Detection result by the VNIR image analysis

According to the field survey, four reservoirs were confirmed in the target area because the slope collapse occurred in the background. Table 2 shows the geology, slope, rainfall and landslide area of the landslide. In this extraction method, six ponds were detected because there was a suspicion of a slope failure behind. Figure 4 shows the results. Of the four locations that had been confirmed in the field survey to have occurred within the target area, all four locations were detected. Since the VNIR image before the disaster was not used in this extraction method, bare land without collapse was also extracted. However, the improvement of the base map makes it possible to evaluate the difference before and after the disaster, and it is also possible to detect only newly occurring slope failures.

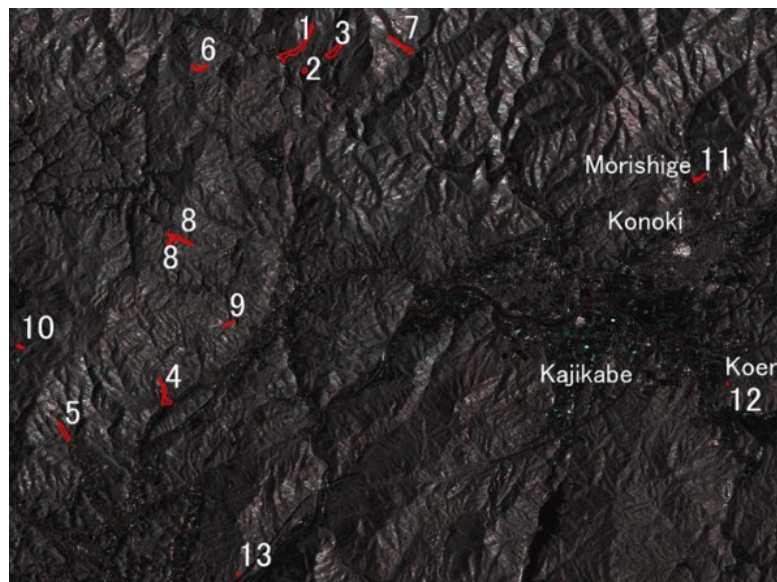
Figure 5. Detection result by the SAR images analysis

In the analysis using SAR images, 13 slope failures were detected within the target area. Table 3 shows the detected geology, slope, and rainfall at 13 locations. Of these, four occurred behind the pond. In fact, two out of four locations where slope failures occurred behind the reservoir were detected. Some ponds could not be detected because the scale of the damage was small compared to the resolution of the image, and the position of the collapse slope was shaded in relation to the orbit of ALOS-2. In the future, it should be investigated how to support the damage detection using ALOS-2 SAR images observed immediately after the damage by combining with the conditions of vulnerability such as rainfall and geology on the geographic information system.

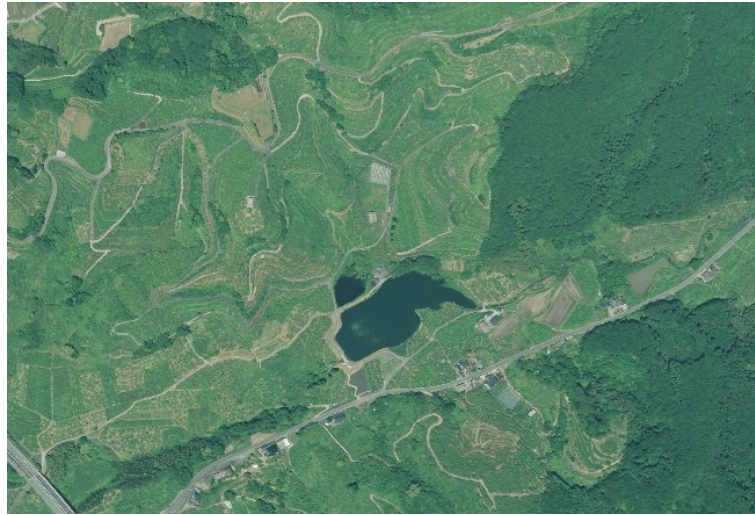
Figure 6. Aerial photo of Yamanokami Reservoir before the heavy rain in 2017 (GSI Japan)

In July 2017, heavy rain in northern Kyushu caused damage to a large-scale reservoir with a breakwater at Yamanokami reservoir in Yamada, Asakura City. Taking this reservoir as an example, how a SAR image captures a larger-scale reservoir breach is shown. Figures 6 and 7 are aerial photographs taken around the reservoir before and after the disaster, respectively, taken by the Geographical Survey Institute (GSI) of Japan. The slope around the pond collapsed because it was located in the center of the surface image, and the pond collapsed due to inflow into the pond and debris flow with driftwood from upstream. After the disaster, the reservoir became flooded and the area became bare. Figure 8 shows the SAR images before and after the disaster subjected to additive color mixing. The area that was the pond water surface before the disaster became strong in cyan because it became bare land. In the area where the surrounding slope collapsed and became cliff-shaped, the red intensity was strong because the scattering intensity was lower than before the disaster. Thus, in SAR image analysis, not only the surrounding slope failure but also the pond break can be detected.
