FLUME EXPERIMENTS ON REVETMENT FAILURE DUE TO BED DEFORMATION DURING FLOOD

ABSTRACT

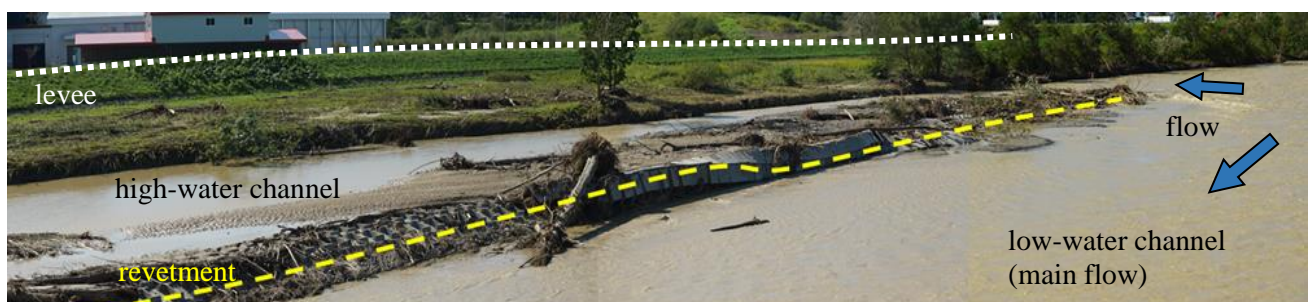
Figure 2. A revetment failure with high-water channel erosion in Otofuke River

However, in a flood event of eastern Hokkaido in August 2016, one of the noticing points was that many of revetment failures were with high-water channel erosion and their foundations weren't damaged severely. Figure 2 shows an example of revetment failures in Otofuke River which is one of tributaries of Tokachi River in eastern Hokkaido. In Figure 2, The revetment is turned over from its back to front and lateral erosion nearly reached to levee's toe. From a report by Hokkaido Development Bureau (2016), some of levees with this revetment failure pattern were in danger of a levee breach while a water level was not so high.

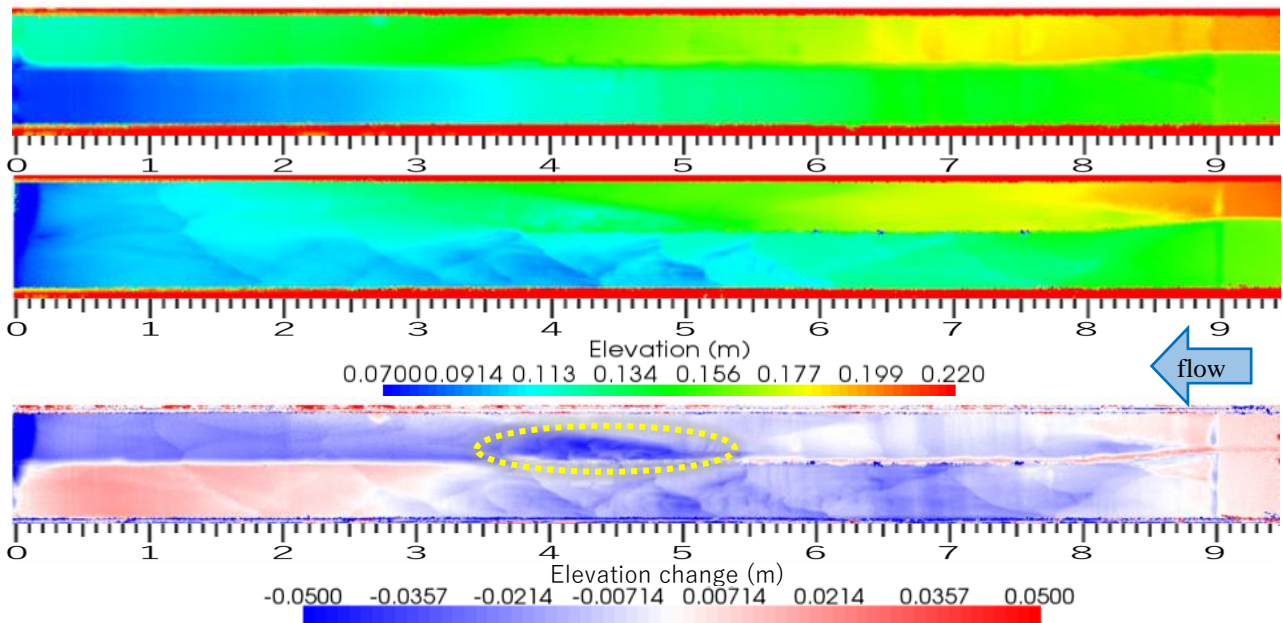
Figure 7 shows contour maps of riverbed elevation before and after the experiment and a contour map of elevation change in Case1. On the low-water channel in middle area of the flume, alternative bars of about 1.6 cm wave height were formed. At some points of the alternative bars' front edge, local scourings in front of the

Figure 7. Ccontour maps of bed elevation before (top) and after (middle), and elevation change (bottom) in Case1

revetment were observed, but those depth were not so deep as the revetment's foundation. On the high-water channel beside the bars, a bed degradation was observed as shown by a yellow circle in Figure 7.

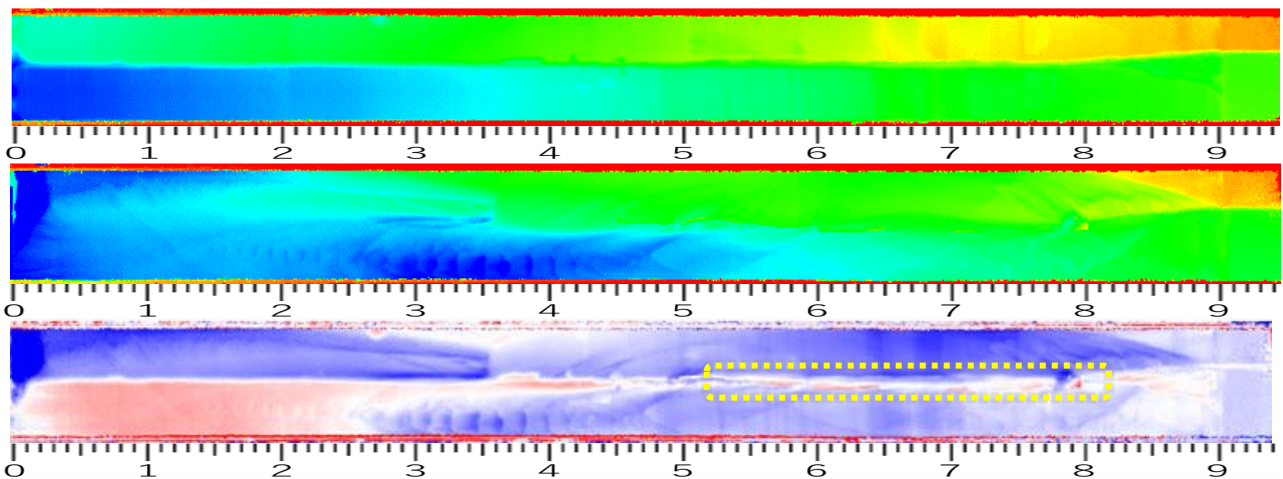
Figure 8. Contour maps of bed elevation before (top) and after (middle), and elevation change (bottom) in Case2 (the color-scales are same as in Figure 7)

In Case2 about 5 minutes after the discharge increase and the flow flooded on the high-water channel, some parts of the aluminum mesh sheet, shown by yellow rectangle in Figure 8, were lifted up. After a few minutes more, those lifted sheets got turned over toward low-water channel. Behind the turned over sheet, wide bed degradation on high-water channel was observed as indicated in Figure 8. Furthermore, there were a dropping flow and sediment transport from highwater channel to low-water channel through gaps between turned over sheets and remaining sheets. This flow and transport appeared to promote the bed degradation on high-water channel.

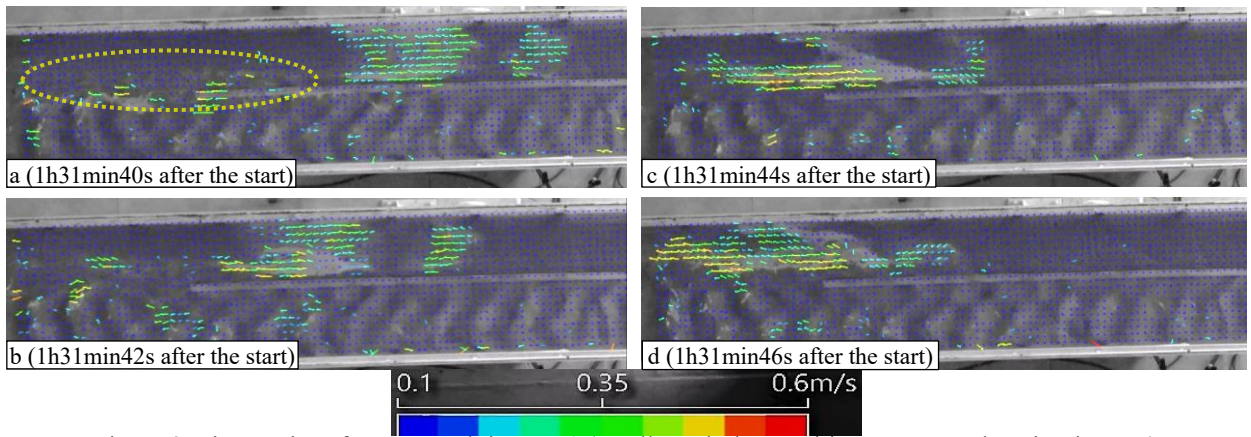
We performed PIV analyses every 10 minutes after the discharge increase. Figure 9 shows one of PIV results which performed about 30 minutes after the discharge increase. From those PIV results in Case1, though there were not prominent overtopping flows crossing the revetment toward the degradation area, a flow on the high-water channel concentrated to the degradation area as shown in Figure 9. By examining time series of PIV results, this degradation took place from the revetment's downstream end. It suggested that the degradation was not caused by a rapid flow or an overtopping flow on the high-water channel along the revetment, but by local scouring at the revetment's end.

Figure 9. Time series of a PIV result in Case1 (a yellow circle's position corresponds to in Figure 7)

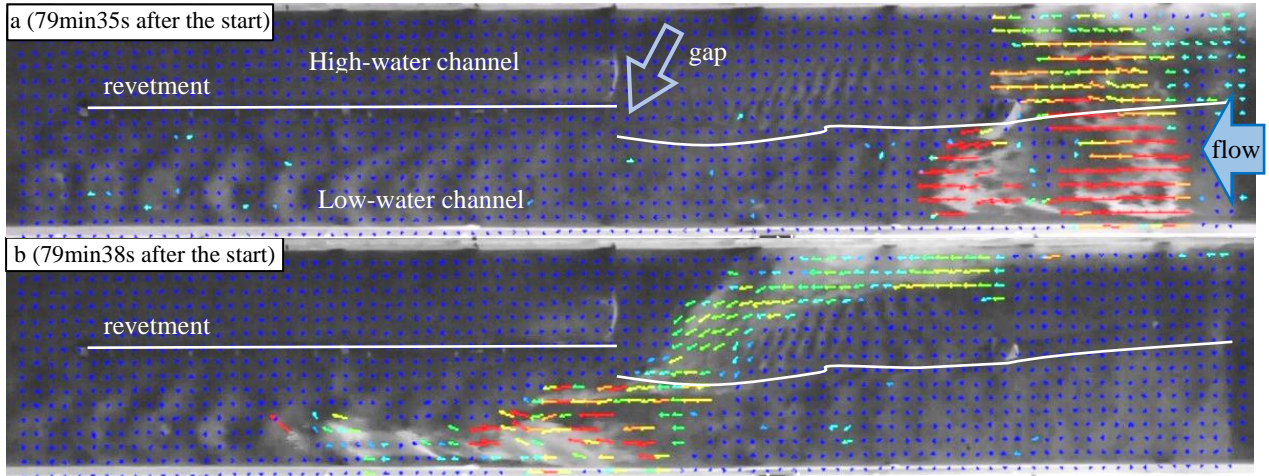
Figure 10 shows velocity vectors by PIV analysis performed 20 minutes after the discharge increase in Case2. In Figure 10a, velocity vectors in upstream area indicates that their velocity was over 0.6 m/s on low water channel and 0.5 m/s on high water channel. As can be seen from Figure 10b, the dropping flow from the high-water channel concentrated in the gap by the mesh deformation. However, its velocity was about 0.4 m/s at most and not so high in comparison with upstream area of the flume.

Figure 10. Velocity vectors by PIV in Case2 20 minutes after the discharge increase (the color-scales are same as in Figure 9)

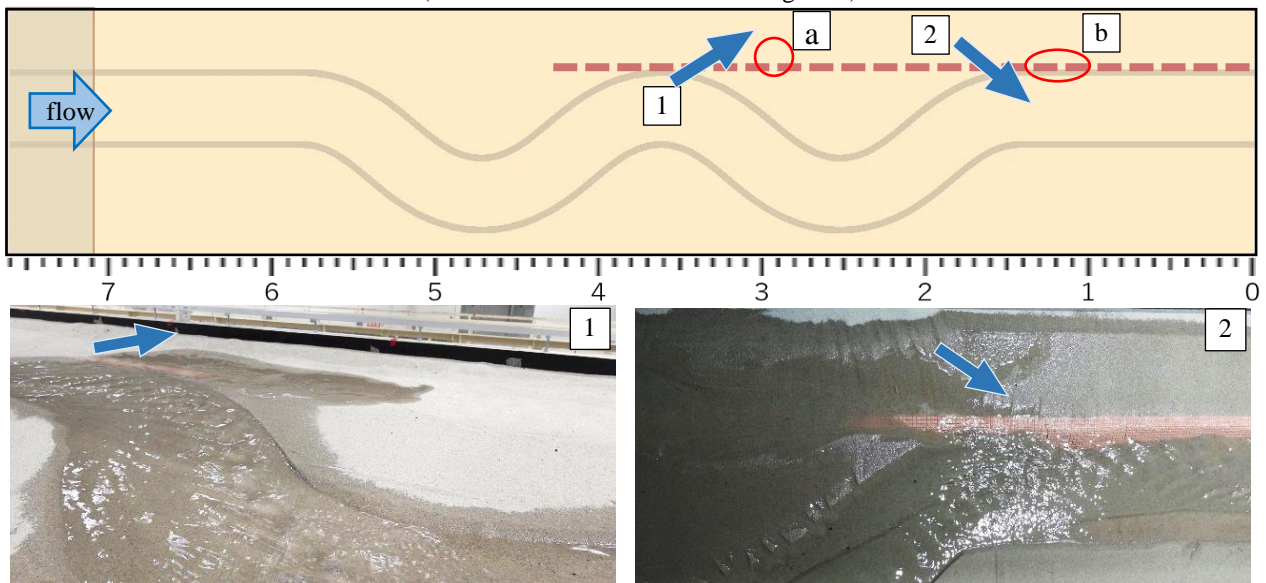
Figure 11. points where overtopping happened in Case3 and photographs of them

This experiment continued for an hour and a half. A few minutes after the experiment started, water flow crossed over the revetment at some points including the outer bend of meandering on left bank side. Figure 11 shows points where overtopping happened. The overtopping flow streamed along the revetment and returned to the low-water channel at the downstream straight channel. There was some damage to the top end of tile sheets and some of tile blocks were fell out around where overtopping happened as shown by a red circle in Figure 12.

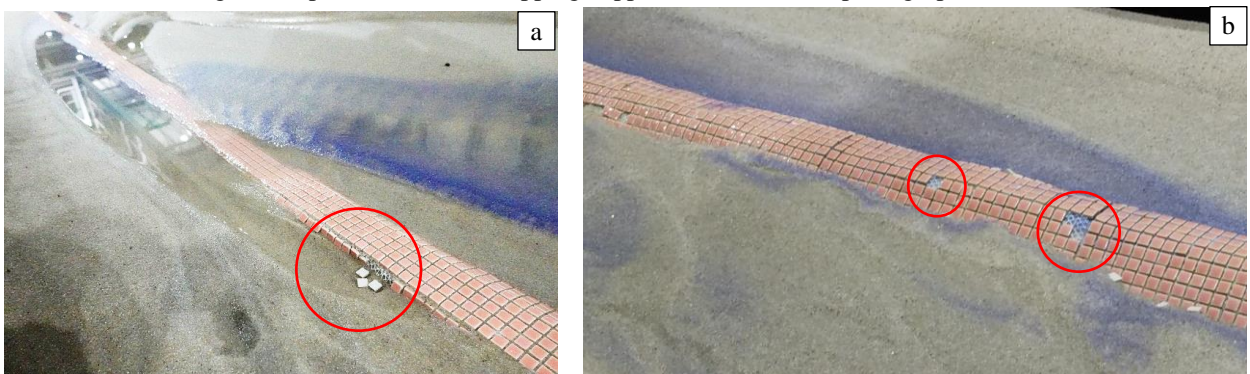
Figure 12. damage to top end and tile blocks' falling out in Case3

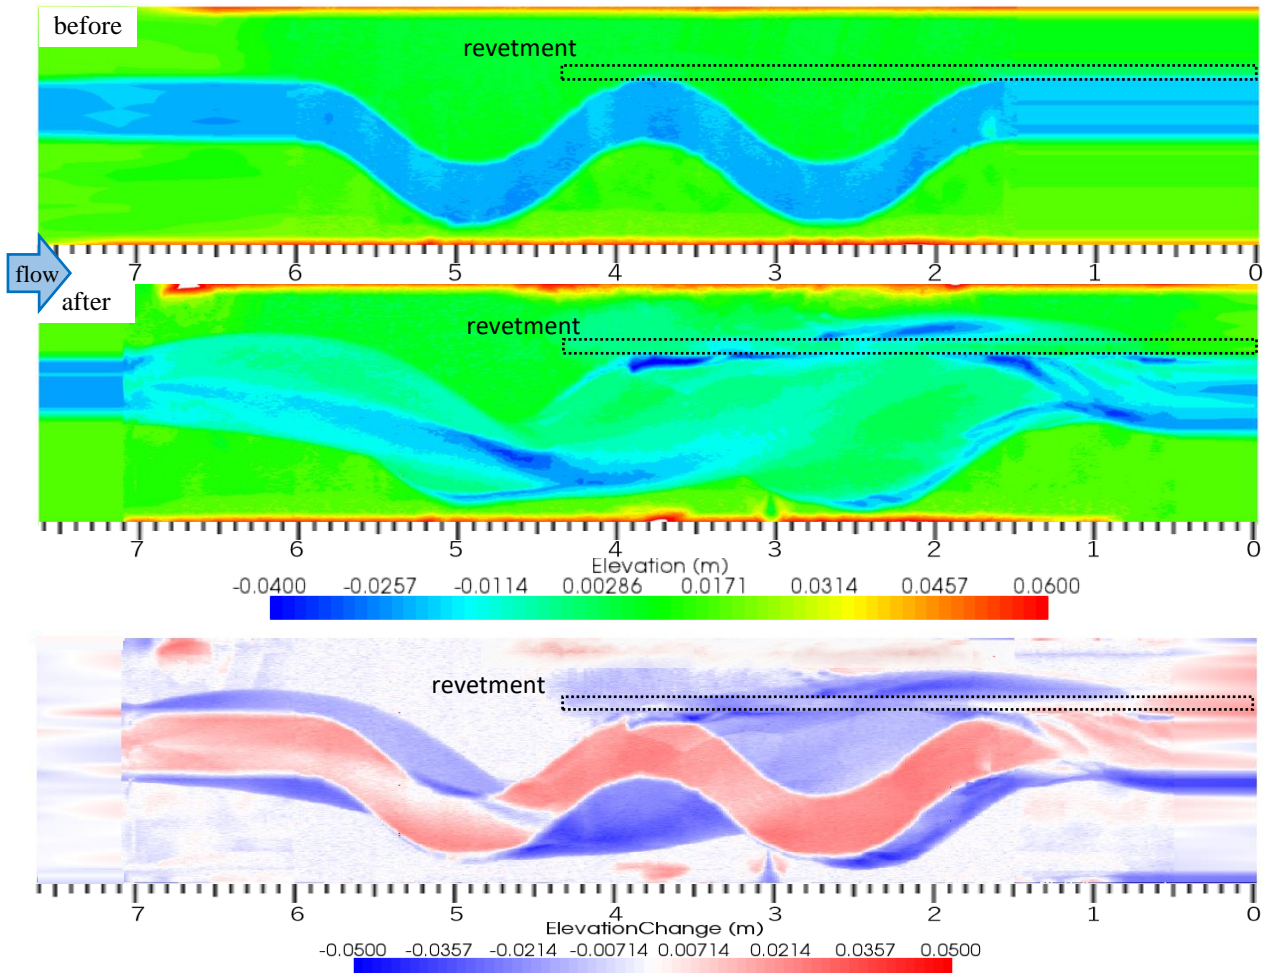
Figure 13. contour maps of bed elevation before (top) and after (middle) without a flume bed's gradient, and elevation change (bottom) in Case3

Figure 13 shows riverbed elevation contour maps without a flume's gradient before and after the experiment and an elevation change contour map of Case3. As can be seen from Figure 13, the meandering channel transformed as below; the meandering channel gradually migrated toward downstream with a decrease of meandering angle. Also, we can observe from the elevation map a remarkable scouring along the back of the revetment around 2 m from a downstream end. This scouring was 50 mm at most and near where the overtopping flow returned to the low-water channel.

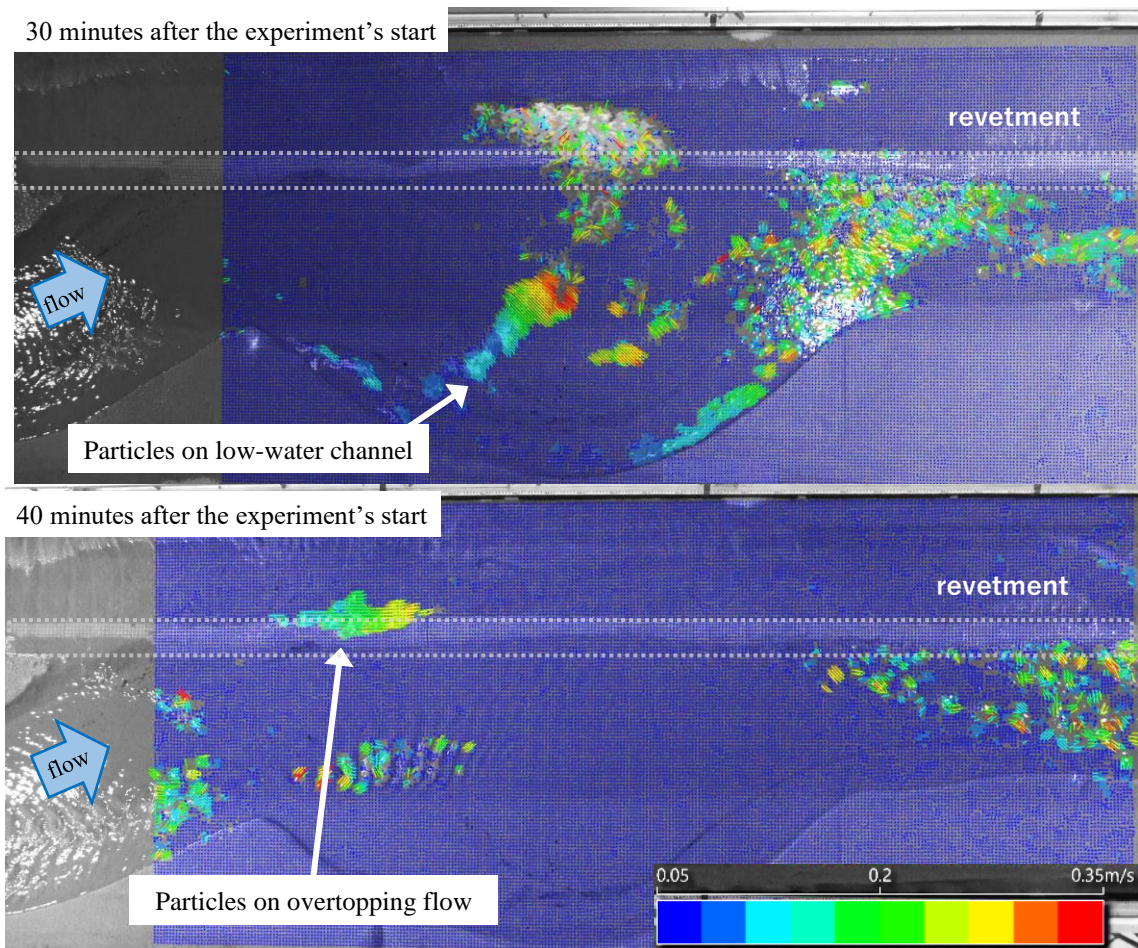
Figure 14. PIV results taking low-water channel flow and overtopping flow in Case3

Figure 14 shows two PIV results performed in 30 and 40 minutes after an experiment's start. Though there are some noises on a downstream area, we can see the velocity of a low-water channel flow and an overtopping flow. According to the Figure 14, a velocity of the overtopping flow was about 0.3 m/s at most, while a velocity on low-water channel was partly over 0.3 m/s. This characteristic of overtopping velocity indicates that there wasn't a rapid flow inducing the scouring behind the revetment shown in Figure 13.
