**Graduate School of Engineering,  
Hokkaido University, Sapporo, Japan**

# Flume experiments on high-water channel erosion and revetment failure during flood

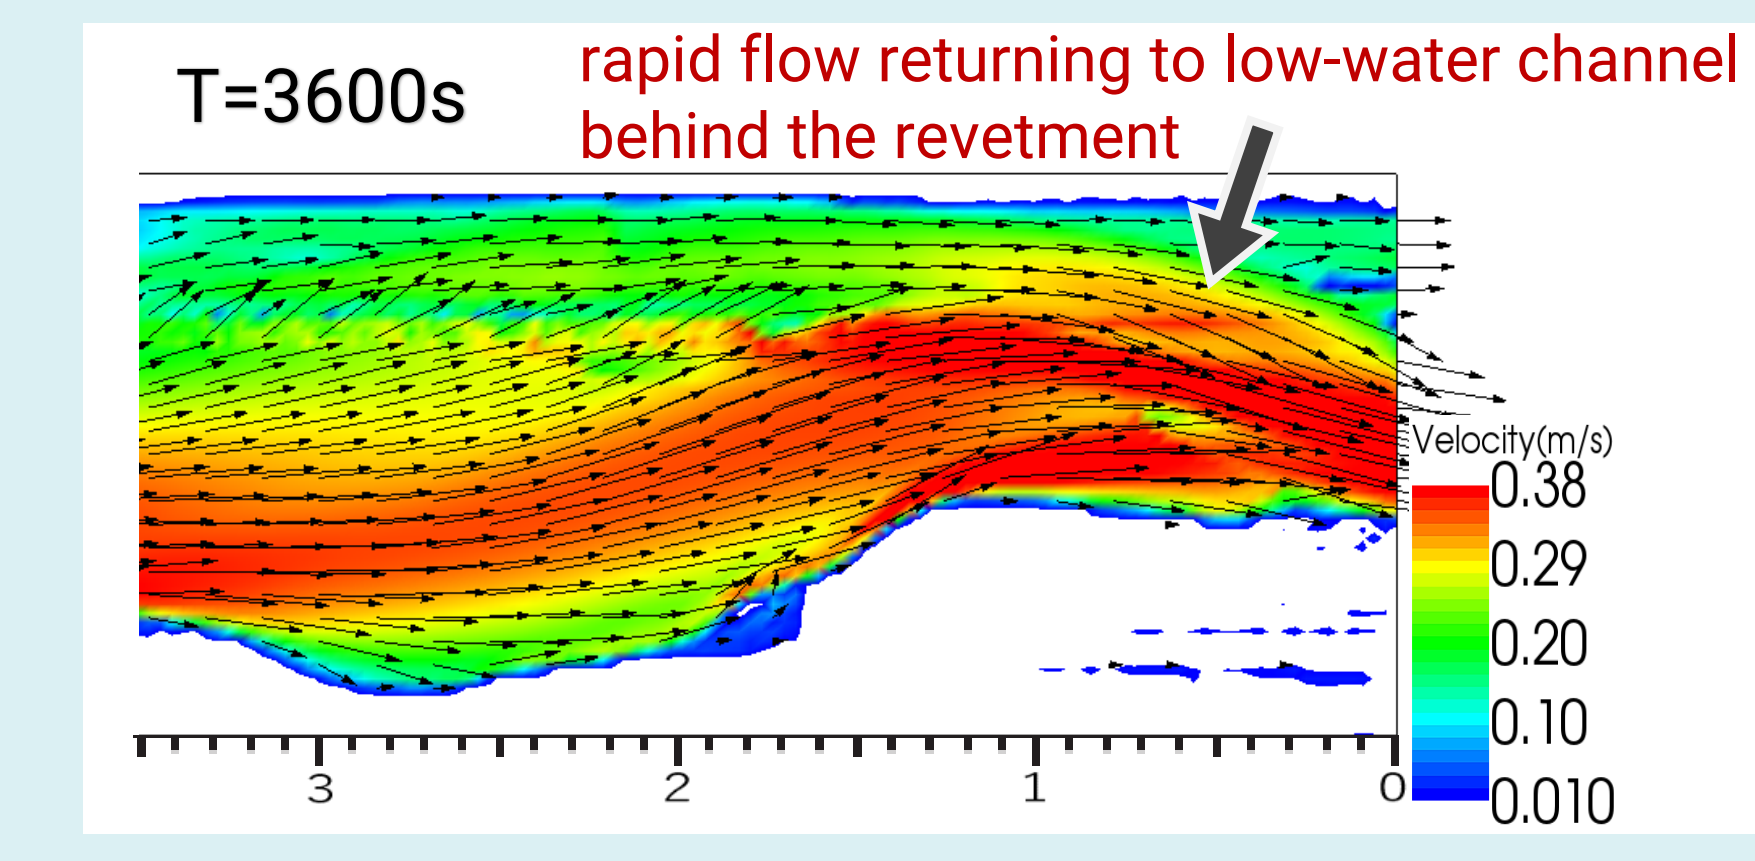
As shown in a graph, bedload flux increased toward downstream and this condition had continued until the computation ended.

- We considered that this tendency was a factor of large-scale high-water channel erosion

From flow velocity distribution in left figure, on high-water channel,

- the overtopping's velocity was relatively low, though the large-scale erosion was developing there
- the maximum velocity was observed where flow returned to low-water channel behind the revetment
- This would cause the revetment failure as in the photo of Otohuke River above.
