## DAMAGE TO BRIDGES DUE TO MEDIUM SCALE FLOODING: A CASE STUDY OF THE IWANE OHASHI BRIDGE

In July of 2018, a flood with return period of 1/15 years attacked the Yubetsu River basin in Hokkaido. The Iwane Ohashi Bridge located in the Engaru Town over the Yubetsu River suffered great damage. This flood resulted in a subsidence of a bridge pier, causing a great deformation of the bridge girder, even though this bridge was designed based on the flood with return period of 1/100 years, which is quite larger than the flood scale targeted here. The detailed understanding of the reason of the damage will provide a useful insight into future management of the river and bridge. In this study, we investigate the main cause of this disaster in detail by using numerical model of flow and bed evolution, iRIC-Nays2DH.

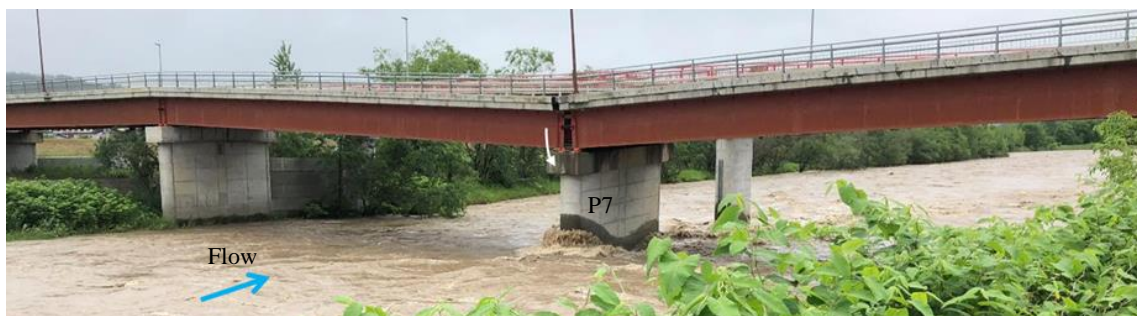
Figure 1. Damage of the Iwane Ohashi Bridge (photo taken from the right bank at July 4th 2018)

From July 1st to 5th of 2018, a heavy rainfall occurred due to the tropical depression that changed from Typhoon 7 in the Hokkaido region, causing a medium flood (return period of 1/15 years) in the Yubetsu River. The Iwane Ohashi Bridge (bridge length is 336.6m, roadway width is 6.75m completed 1980) (Kokozo Shuppan, 2019) located in the Engaru Town over Yubetsu River suffered a heavy damage. This flood resulted in a subsidence of a bridge pier, causing a great deformation of the bridge girder as shown in Fig.1 This bridge was designed based on the flood with return period of 1/100 years, which is quite larger than the flood scale targeted here, so that the detailed understanding of the reason of the damage will provide a useful insight into future management of the river and bridge. In this study, we investigate the main cause of this disaster in detail by using numerical model of flow and bed evolution, iRIC-Nays2DH.

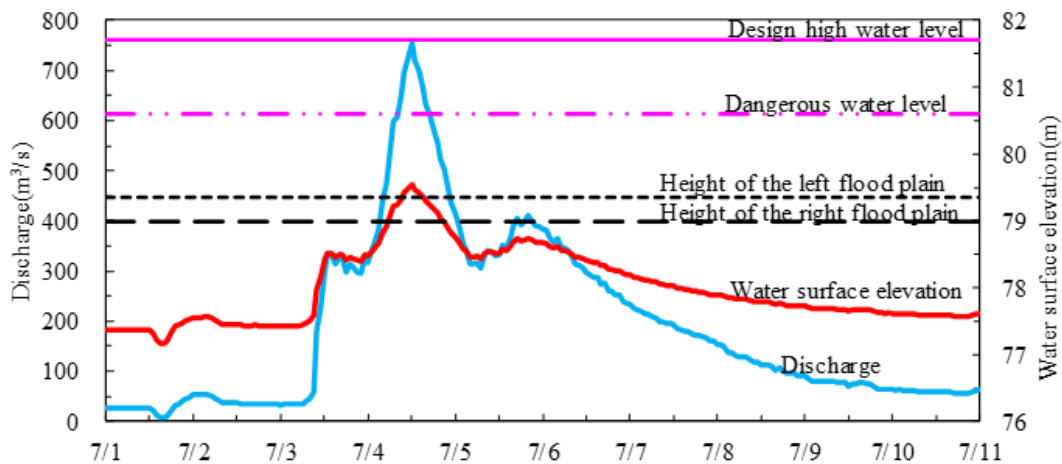
Figure 3. Discharge and water surface elevation observed from Engaru Observatory Station

10th (see Fig.3) is imposed at the upstream boundary. The computational grid sizes in streamwise and transverse directions are about 4m and 2m, respectively.

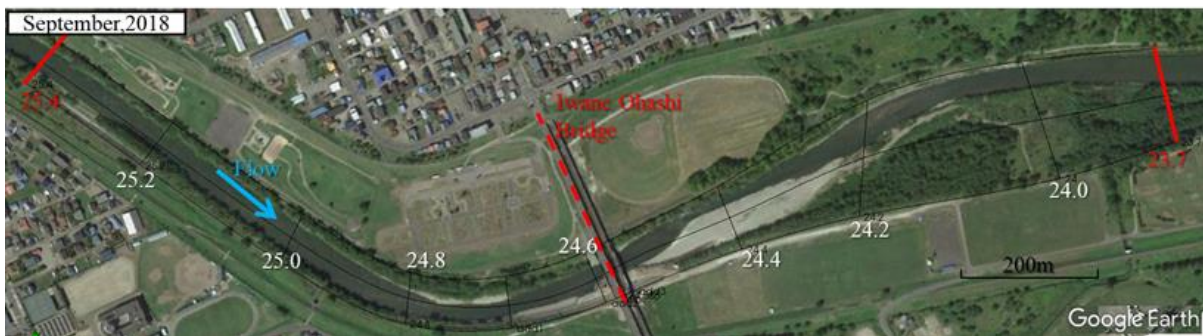
Figure 5. Objective reach of the calculation (Edited image of Google Earth)

Fig.5 shows the target river reach of the calculation (approximately 1.7 km long). The cross-sectional geometry measured in February of 2018 (spatial interval of the measurement is 200 m) was used for initial bed geometry of the computational grid. In this calculation, we neglect the presence of bridge pier, but the foot protection on the river bed around the pier and some revetments are considered as fixed bed. This is intended to focus on fundamental features of bed evolution in this reach during the targeted flood event. More specifically, we herein pursue whether or not the bedform could have significant impact on the observed damage of the bridge. The observed unsteady discharge at Engaru Observatory station from July 3rd to July

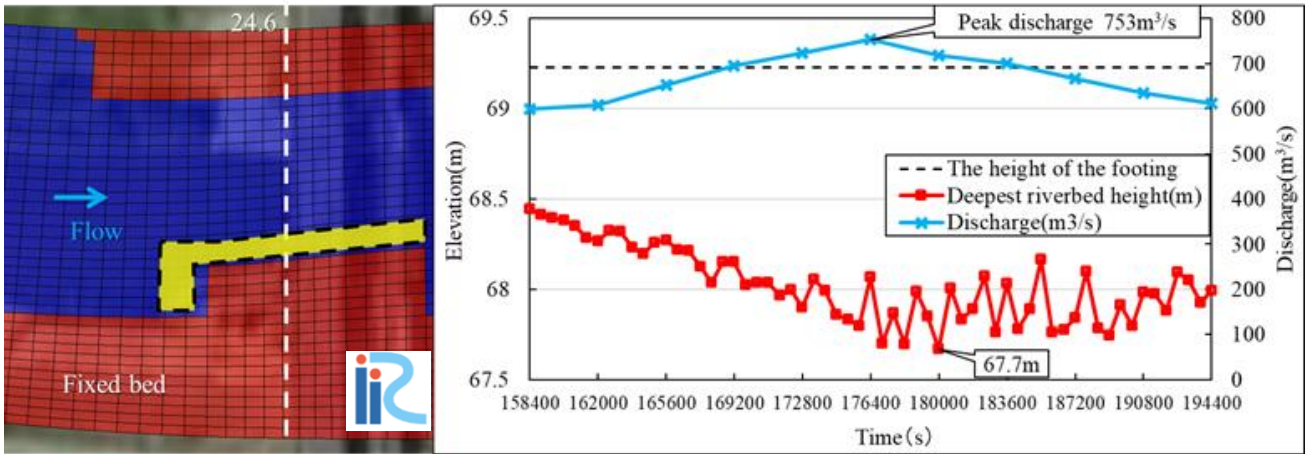
Figure 7. The temporal change of the deepest bed elevation around the foot protection (indicated as yellow area on the left figure)

For reference, the relationship between the scour around the foot protection blocks and the cause of the damage is confirmed. Fig.7 shows the temporal change of the deepest riverbed elevation among the grid

points (indicated as yellow) around the foot protection. The elevation of the deepest point is 67.7m at 6 hours after the peak discharge. This is about 1.5m lower than the height of the bottom of the footing of the sinking P7 pier, it is presumed that the riverbed of the foot protection blocks and the pier was considerably lower than the footing height of the pier.

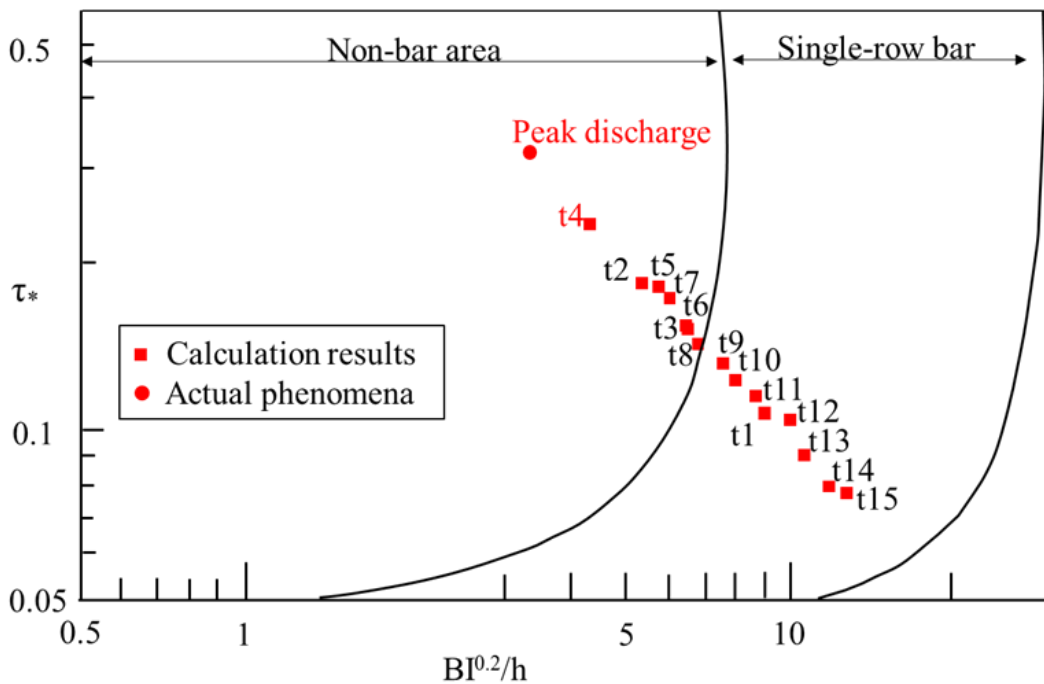
Figure 8. The bar regime change during the event on the diagram proposed by Kuroki and Kishi (1984)

We next focus on the bedform and bar regime change during the flood event to understand the effect of such bedforms, which are oriented by a spontaneous (instability-related) response of the bed, on the damage of the bridge. Fig.8 shows the bar regime changes estimated for this flood event on the diagram proposed by Kuroki and Kishi (1984). In the figure, "Actual phenomena" is calculated using the actual observation data, "Calculation results" in the figure is calculated using the time series calculation results data (e.g., water surface elevation). As shown in Fig.9, several flood stages are represented as t1 to t15. Fig.8 indicates that during the high discharge, bars (i.e., alternate bars) is not able to form, on the other hand, the alternate bars may be developed on the low discharge condition (i.e., at very beginning of the flood (t1) and at the latter half of the flood (after t9)). In addition, Fig.10 shows bedform regime change during the flood on the diagram proposed by Ashida and Michiue (1972), suggesting transition regime for the entire flood period.

Both figures indicate that dominant bed feature during the high discharge condition is classified non-bar regime of medium scale bedform and transition regime of small scale bedform in this reach. In the calculation during the high discharge, dune-like bedforms moving are also confirmed, so these bedforms may have effects on the damage of the bridge. This is consistent with the fact that the damage of the bridge was observed just before the discharge peak, so that there might be another factor causing this damage.

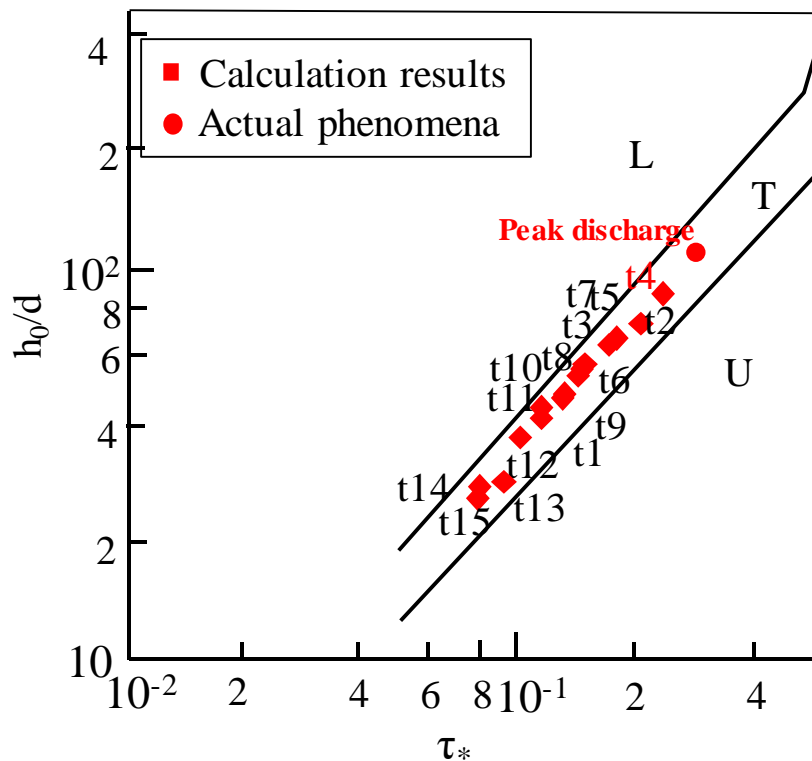
Figure 10. The bedform regime change in the targeted flood on the diagram proposed by Ashida and Michiue (1972)

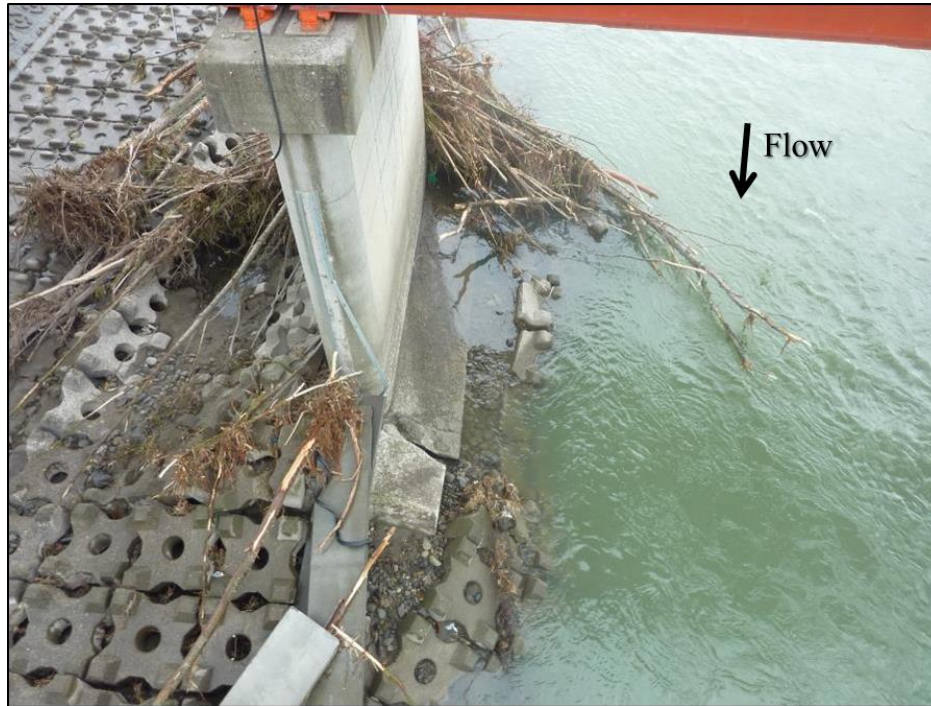
Figure 14. Damage situation of the rooting blocks (Photo taken by Okhotsk General Subprefectural Bureau Abashiri Department of Public Works Management)  
(Edited image of Okhotsk General Subprefectural Bureau Abashiri Department of Public Works Management)

Fig.14 is a photograph of the damage situation of the foot protection blocks taken after the flooding. It is confirmed that foot protection blocks on the right bank of the pier was severely damaged. The reason that the pier was inclined to the right bank side is probably due to severe damage to the foot protection blocks. In addition, the foot protection blocks on the left bank side of the pier was also severely damaged, and the footing of the pier was exposed. The calculation results suggest that the riverbed on the front and side of the foot protection blocks was greatly scoured, which is consistent with the observation.
