## **RIVERBED VARIATION AS INFLUENCED BY NATURAL AND HUMAN-INTERFERED PHENOMENA OF GENDOL RIVER, MT. MERAPI AREA, INDONESIA**

### **ABSTRACT**

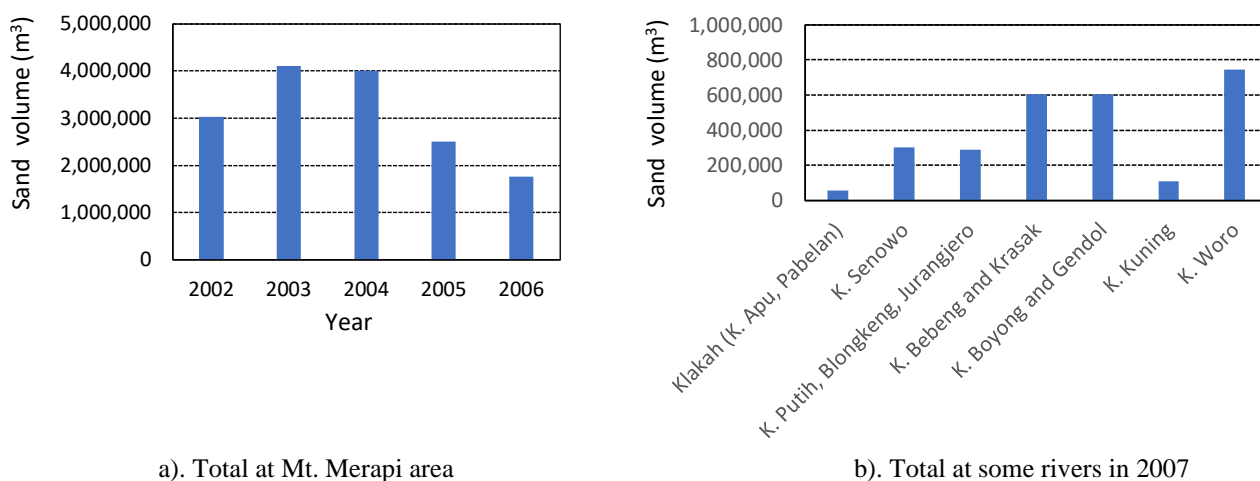
Figure 3. Sand mining volume at Mt. Merapi area (DGWR, 2010).

The hydro-environment complexity arises in the form that too much sediment in the river may bring about the insufficient capacity of the river to store the sediment inflow, however, less sediment may cause riverbed degradation. The continuous degradation would further bring about the instability of the sediment control structures. The volume of sediment that has been resulted from sand mining activity during the few years before the 2010 eruption was found to be very significant (see Figure 3). It is seen from Figure 3 a) that during 2002 thru 2006, sand mining activity varied considerably with the maximum and minimum volume that took place in 2003 and 2006 respectively. The 2006 eruption has made the activity decreased significantly because the sand miners considered their safety from pyroclastic (lava and lahar) flow disaster. Survey on sand mining activity as a part of Study on Institution and Community Development (DGWR, 2010) showed the condition of sand mining activity on several rivers at the Mt. Merapi area and the approximation of 2007 sand mining volume as shown in Figure 3 b). The total sand mining volume at the Mt. Merapi area as shown in Figure 3 b) is approximated to be 2,711,320 m<sup>3</sup>, much larger than it was in 2006 (1,762,000 m<sup>3</sup>). Additionally, the approximated 2007 sand mining volume at Gendol and Boyong River was found to be 600,000 m<sup>3</sup>, this was about 22% of the total sand mining activity that took place in the whole area of Mt. Merapi. Indeed, the fluctuation of pyroclastic material availability seems to be very important for predicting any business related to sand mining.

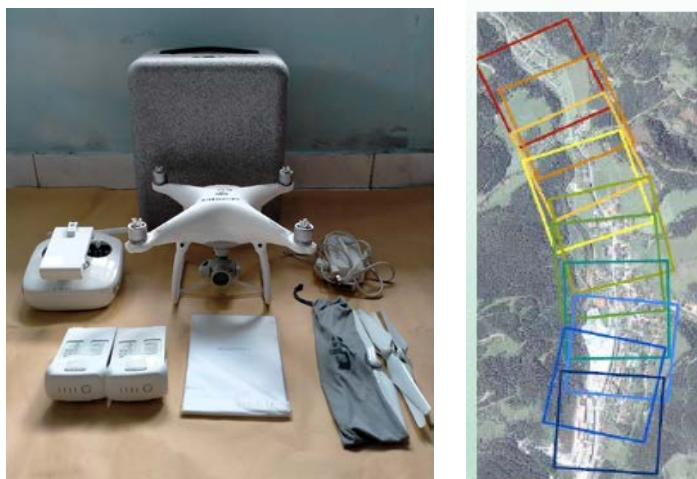
Figure 4. Drone and over-lapping/side-lapping techniques of photo aerial mapping.

The Unmanned Aerial Vehicle (UAV) platforms were a valuable source of data for inspection, surveillance, mapping and 3D modeling issues (Remondino et al., 2011 and Nex, et al., 2014). The UAVs have been a low-cost alternative to the classical manned aerial photogrammetry. Rotary or fixed-wing UAVs, capable of performing the photogrammetric data acquisition with amateur or SLR digital cameras, can fly in manual, semi-automated and autonomous modes (Shikada, et al., 2011). The latest developments of UAV image processing methods for photogrammetric applications have been reported, including mapping and 3D modeling issues. The UAV or unmanned aircraft is a flying machine with remote control by a pilot or by an autopilot. Two types of UAV have been widely used, i.e. the wing type and the rotary typed (further known as drone). Drone technology has been used in various countries not only for taking aerial photographs or videos but also used in the remote sensing process (Ren, et al., 2019). For making Digital Elevation Model (DEM) maps or topographic maps, the use of drones using cameras is still not widely used, which is commonly used in mapping are drones equipped with Light Detection and Ranging (LIDAR) and Terrestrial Laser Scanning (TLS). The technique used in making DEM maps using drone cameras is called photogrammetry (see Figure 4). With this technique, the properties of the geometry of an object obtained from many images can be known. These images must be overlapped with one another in the same section of the image. The wider the overlapping area, the more accurate the results obtained. Drone technology can be used to make technical maps both from Digital Surface Model (DSM) maps, Digital Terrain Model (DTM) maps, and the final result in the form of contours with high accuracy.

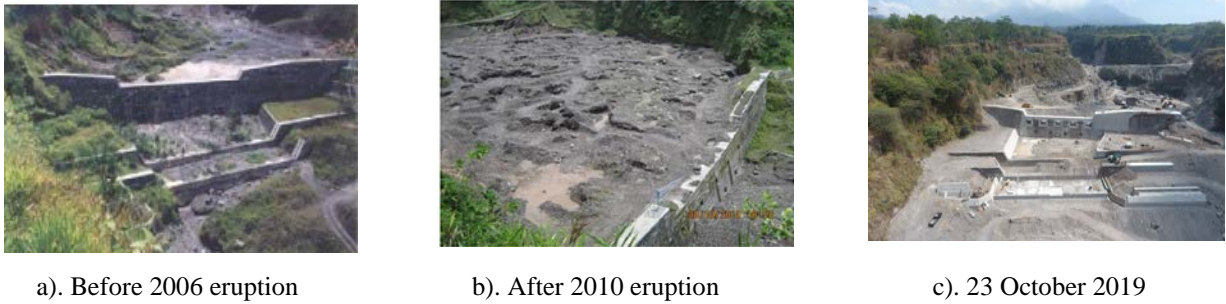
Figure 5. Topographical condition at near upstream of GE-D5

Monitoring of river morphological changes due to natural processes and accelerating processes can be done with a remote sensing approach using high-resolution data. Two main activities that are considered essential as a basic requirement to describe the morphological changes they are the remote sensing and the DEM processing. The drone technology was used in identifying the morphological changes of upstream GE-D5, besides, the sediment balance was also analyzed based on the empirical formula. The topographical conditions near upstream of GE-D5 at three different times of observations are shown in Figure 5. Further monitoring on

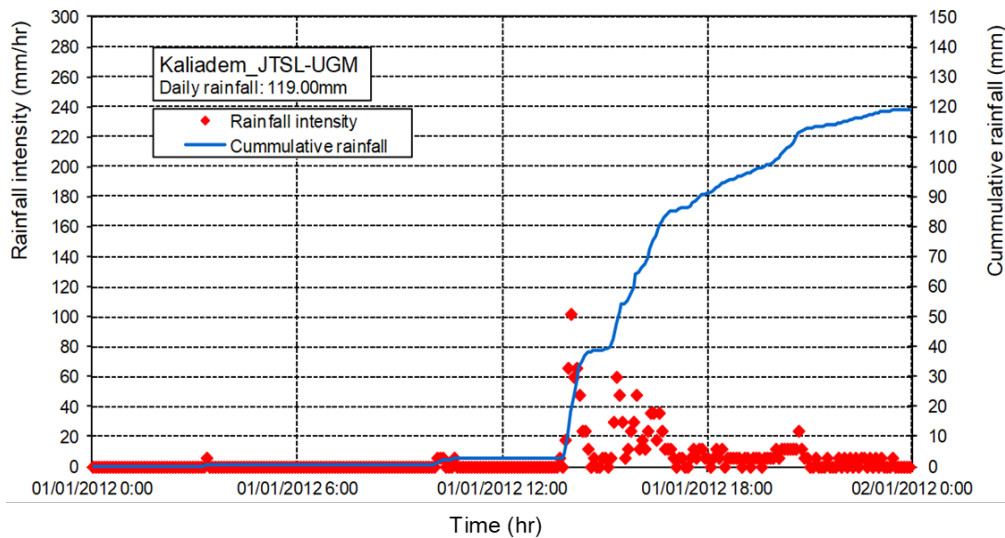
Figure 7. Rainfall intensity at Kaliadem on 1<sup>st</sup> January 2012 that causing debris flow.

One of the objectives of this study is to estimate the sediment volume that has been withdrawn by the sand mining activity through the identification of the changes in topographical condition. The sediment volume that has been supplied by the rainfall-triggered debris flow was considered insignificant since there was no record on the debris flow occurrence within the period of the study. The rainfall occurrences that took place during the period of 23 October 2019 through 22 January 2020 is shown in Figure 6. Such occurrences are considered not significant to trigger the debris flow occurrences; therefore, no sediment had been supplied during the period under investigation. The daily rainfall during October 2019 is shown in Figure 6 a). with the highest rainfall took place on 31 October 2019 with the five minutes distribution is shown in Figure 6 b), no debris flow occurrence had been reported. The change in the topographical condition was mainly due to the sand mining activity. Previous studies on various rainfall conditions triggering debris flow occurrences in Gendol River (Fibriyantoro, 2015) showed the debris flow occurrence even with the relatively low rainfall intensities, i.e. 100 mm/hr and the daily accumulative rainfall at 119 mm (see Figure 7).
