EFFECT OF DIFFERENCE IN SHAPE OF STEPPED FISHWAY ON FLOW STRUCTURE

TAKAYUKI TANAKA (National Institute of Technology, Toyota College, Toyota, Japan)
 KEIGO AOKI (National Institute of Technology, Toyota College, Toyota, Japan)

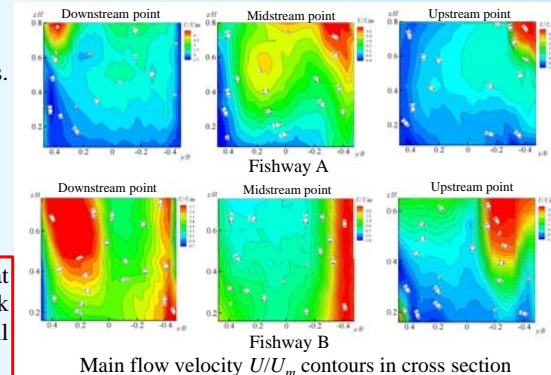
MAIN FLOW VELOCITY CONTOURS IN CROSS SECTION

Fishway A

In each case, the main flow velocity is small near the bottom, which is considered to be a rest space for fishes.

Fishway B

At the downstream point, it can be seen that the influence of the submerged mouth is on the right bank side, and the effect of the upstream notch remains near the water depth.

Compared with the Fishway A, it was clarified that there was no clear space for the fish to take a break because the sections where the flow velocity was small were different in each section.

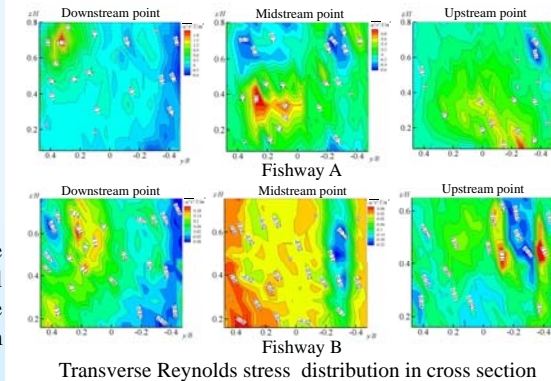
TRANSVERSE REYNOLDS STRESS DISTRIBUTION IN CROSS SECTION

Fishway A

At midstream point, the Reynolds stress shows a positive extreme value below the half water depth on the left bank side from the center of the channel, and it can be confirmed that the three-dimensionality of the flow is strong.

Fishway B

At the midstream point, it can be confirmed that the right bank shows negative values in the vertical direction due to the effects of the notch on the upstream side and the submergence on the downstream side.
