PERFORMANCE EVALUATION OF BANDAL-LIKE STRUCTURES FOR SEDIMENT MANAGEMENT IN BRAIDED JAMUNA RIVER

ABSTRACT

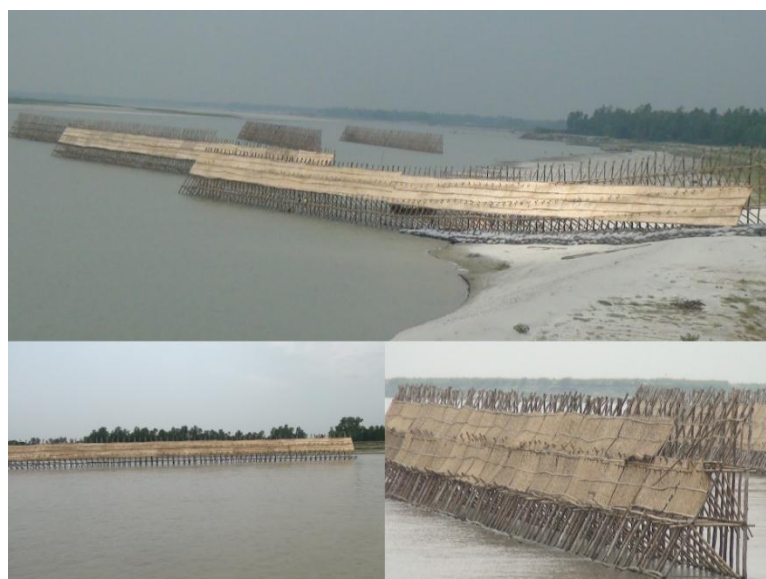
Due to severe erosion at the right bank of Jamuna River, 1500 m reach of the right bank of Jamuna River near Kazipur upazilla at Sirajganj, Bangladesh was selected to conduct the experiment. A set of five prototype bandals were installed at the right bank of Jamuna River near Kazipur. Locally available bamboo and Eucalyptus tree were used to set up the bandal-like structures. Among five bandals, the first bandal is bank attached and the rest of them are 30 m, 60 m, 90 m and 108 m apart from the river bank respectively (Figure 1). The first bandal was installed at 125 m downstream of shingrabari spur at a 30 degrees angle with the bank line. The first two sets of bandals were 100 m in length and the rest three bandals were 200 m individually. The total height of the bandal was 13.5 m where 7 m was placed underwater from the low water level of the river. Geo bags having 175 kg each were given in three layers at the river bed. The top 3 m of bandal was maintained impermeable by locally made tarjah.

Figure 1. Alignments of Bandal-like Structures at Kazipur

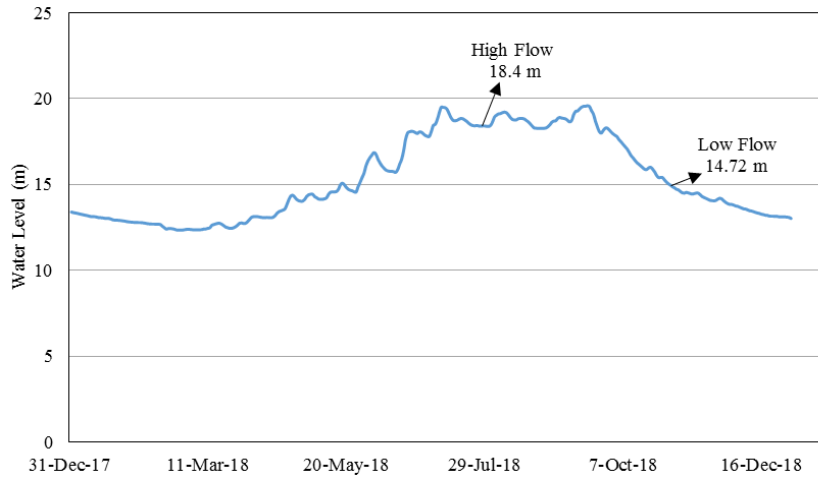
Figure 2. Water Level Variation around Bandal-like Structures at Kazipur

Flow velocities and bathymetry around bandal-like structures were measured in the selected areas using moving boat acoustic Doppler current profiler (ADCP) and echo-sounding technique. The riverboat moved at speeds of 0.5-1.5 m/s during data measurements at 15-30m intervals. The position of the recording data was determined by Trimble SPS461 GPS Heading Receivers. The accuracy of horizontal and vertical DGPS positions is $\pm 0.25\text{m}$ and $\pm 0.50\text{m}$. Flow velocity and discharge were measured using ADCP of 600 kHz (Workhorse Rio Grande 600 kHz, Teledyne RD Instruments, Inc.). The corresponding spatial coordinates were specified by the integration with GPS through RS-232 to the RR data stream. The ADCP was used for water depths 0.4~60m. The bathymetry measurements were carried out using a double beam Echo sounder (echo-trac CVM) with an ultrasonic frequency of 200 kHz, a sampling rate of 33 Hz. The device can be used for water depths 0.2~200m with an accuracy of $\pm 0.1\%$ of depth. Measurements were conducted on 27th July 2018 and 3rd November 2018 during the high flow and falling stage respectively (Figure 2).

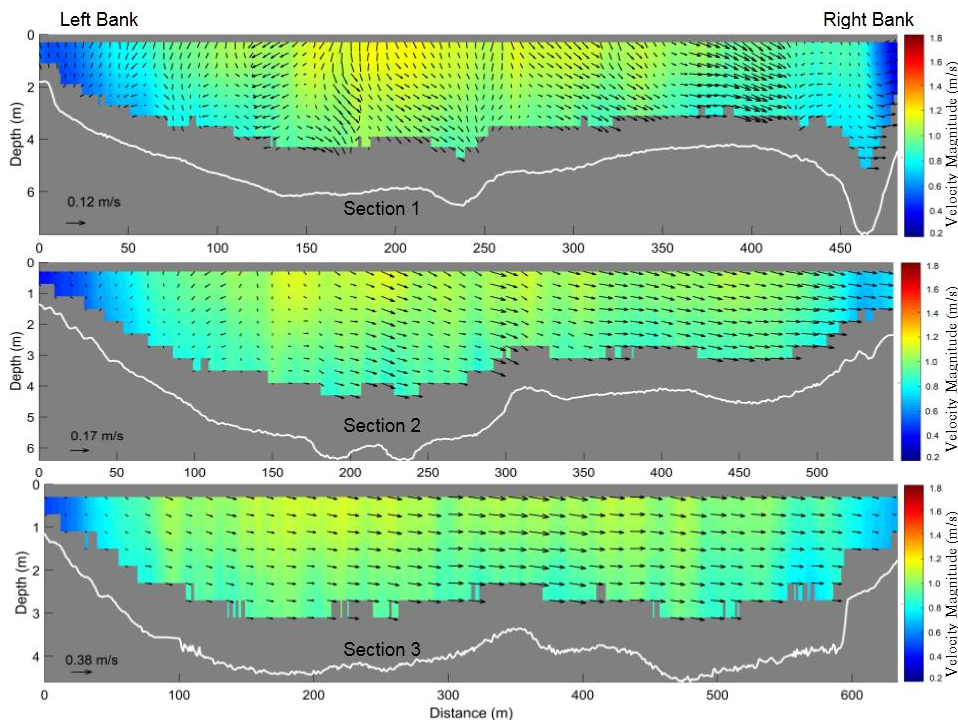
During the low flow period on 3rd November 2018, the contour of (v, w) velocity field seemed less concentrated than the high flow period. Velocity (v, w) was higher in the 1st section which is just before the 1st bandal-like structure. The transverse flow velocity is much higher in that region than w (vertical) flow (Figure 7). Alternatively, in sections 2 and 3 velocities (v, w) seemed steady than the high flow period. It is also noticeable that the flow depth of sections 2 and 3 was higher in the main channel which was previously higher near the river bank during the high flow period.

Figure 7. Flow velocity (v, w) before (Section 1), middle (Section 2) and after (Section 3) the Bandal-like structures during low flow period
