DETECTION OF RISKY MOUNTAIN STREAM AND SLOPE FAILURE AREA IN NOROGAWA RIVER BASIN USING GIS AND OPTICAL SATELLITE IMAGE

ABSTRACT

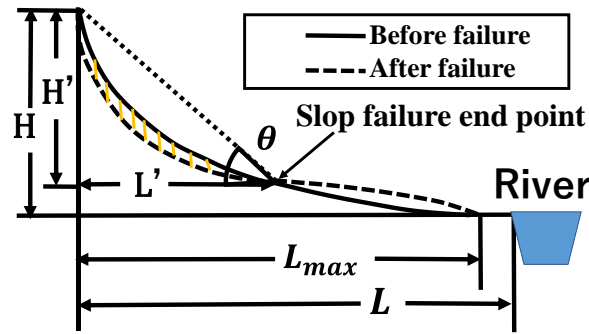
Figure 7. Schematic sketch of slope failure and maximum reaching path of sediment

A maximum reaching path of sediment L_{\max} is schematically shown in Figure 7. In this figure, θ is the slope angle, H is the height between the slope edge and the ground level, L is the horizontal distance from the slope failure occurrence point to the river, H' is the height between the slope failure occurrence point and the slope failure end point, L' is the horizontal distance from the slope failure occurrence point to the slope failure end point. If L_{\max} is longer than L , the sediment can reach the river, so that we tried to choose the mountain stream along which the sediment can reach the Norogawa River using Eq. (3) proposed by Moriwaki (1987). Here after, we call this mountain stream a path reaching the river. On the other hand, the mountain stream along

$$\frac{L}{L_{max}} = 0.73 \tan \theta - 0.21 = 0.73 \frac{H'}{L'} - 0.21 \quad (3)$$
